## **Analysis of the Stability of the Mining Site Slope on Bunyu Island, Bulungan Regency, North Kalimantan Province**

<sup>1-2</sup> Geological Engineering Department, Faculty of Engineering, Universitas Hasanuddin, Indonesia

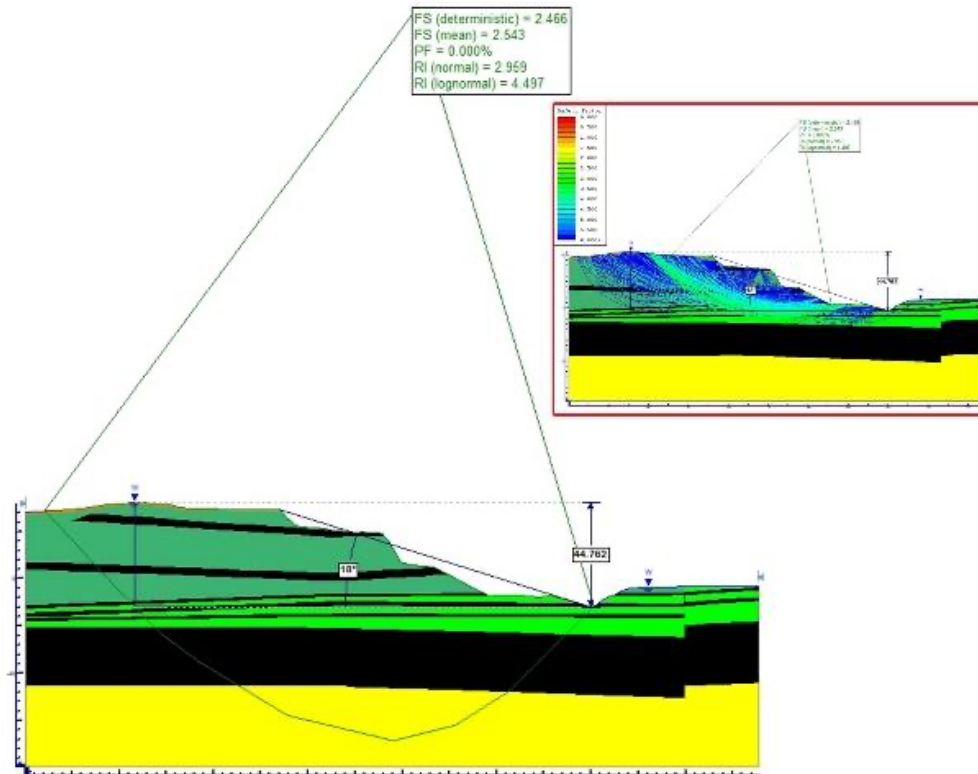
Figure 5. Analysis Results in section 1 of the South Block

Based on the results of the analysis of the geometry of the slope of section 1 which has a slope height of 44,762 meters and a slope slope of 18°, a *Factor of Safety (FoS)* value of 2,543 was obtained with a *Probability of Failure (PoF)* obtained of 0% in a fully saturated condition which means that the slope geometry in section 1 is declared stable according to the KEPMEN 1827 standard.

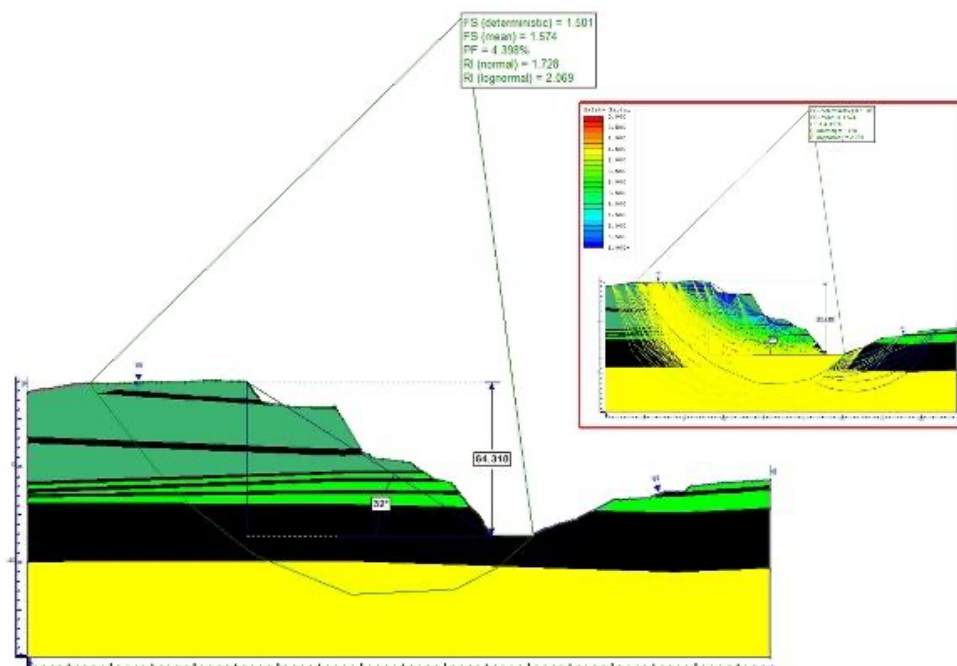
Figure 6. Results of analysis of section 2 of the South Block

Then for the results of the analysis of the geometric stability of the slope section 2 which has a slope height of 64,318 meters and a slope slope of 32°, it produces a value of *Factor of Safety (FoS)* 1,574 with *Probability of Failure* is 4.39% (Figure 14) in the water saturated condition (*full saturated*) which means that the slope geometry in section 2 is declared stable according to the KEPMEN No.1827 standard.

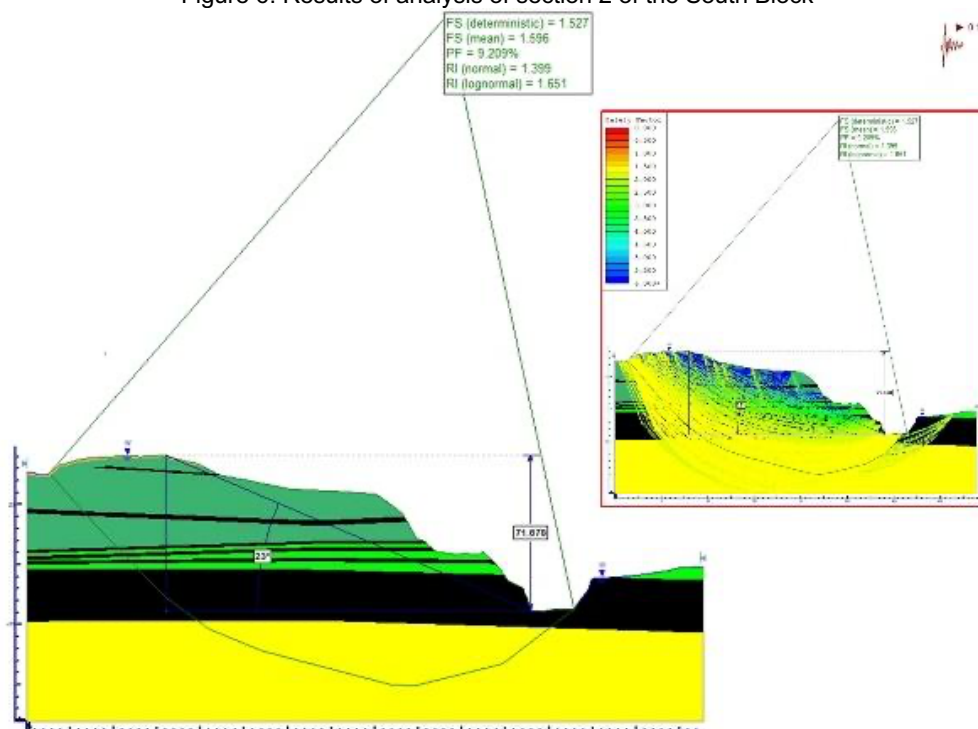
Figure 7. Analysis Results section 3 South Block

In section 3 with a slope height of 71,678 meters and a slope of 23°, the value of *Factor of Safety (FoS)* of 1,596 with *Probability of Failure (PoF)* is 9.20% in the water saturated condition (*full saturated*). Although the FoS value is still above the minimum limit, the magnitude of the PoF value shows that the slope geometry in this section tends to be unstable according to the KEPMEN No.1827 standard.

The results of the analysis of incision 3 in the South block, which previously had slope geometry, had reached a safe safety factor value of 1,596, but the probability of failure value still did not meet the standard with a value of 9.20%. In this reconstruction process, the overall slope was maintained at  $23^\circ$  but the elevation was lowered from 71.6m to 70m. The recommendations made on this incision resulted

in a safety factor value of 2,249 and a probability of failure value of 0% and was declared stable according to the standard.

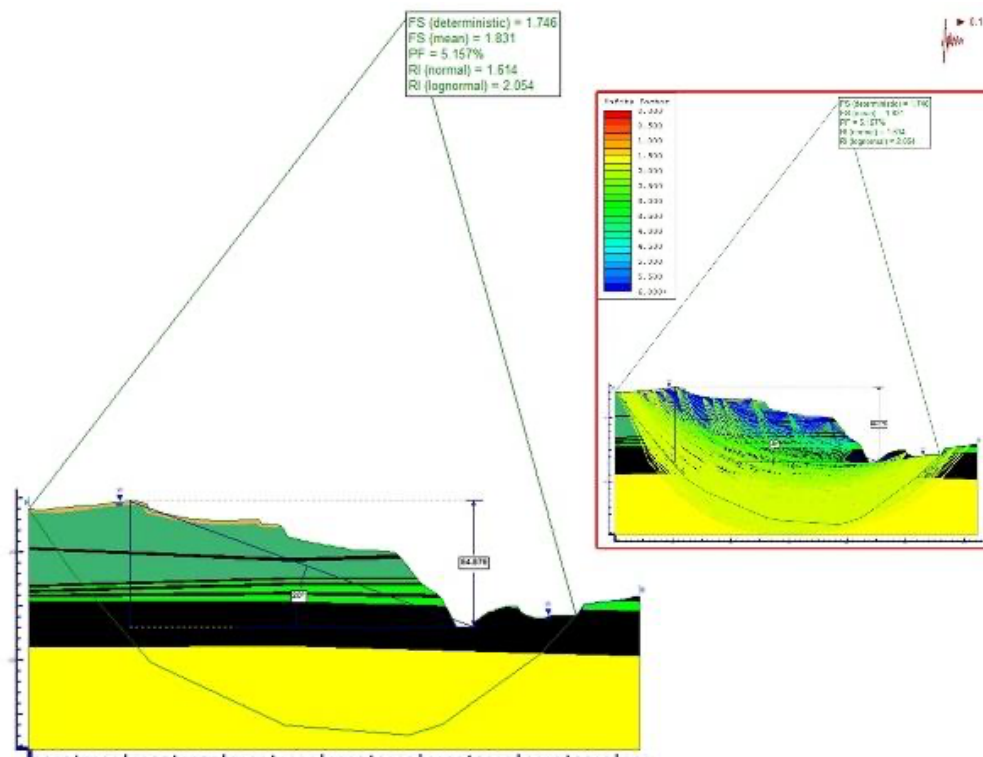
Figure 8. Results of analysis section 4 of the South Block

The analysis in section 4 has an altitude of 64,876 meters and a slope of 20°. The safety factor of this section is 1,831 with Probability of failure is 5.15% in the water saturated condition (*full saturated*) which means that the slope geometry in section 4 is declared unstable according to the KEPMEN No.1827 standard.

The results of the analysis of incision 4 in the South block, which previously had slope geometry, had reached a safe safety factor value of 1,831, but the *probability of failure* value still did not meet the standard with a value of 5.15%. To optimize the design, reconstruction was carried out by adding new benches, lowering the elevation from 64.8 m to 62 meters and raising the *overall slope* from 20° to 21°. The recommendations made in this incision resulted in a safety factor value of 1,854 and a *probability of failure* value of 0%.

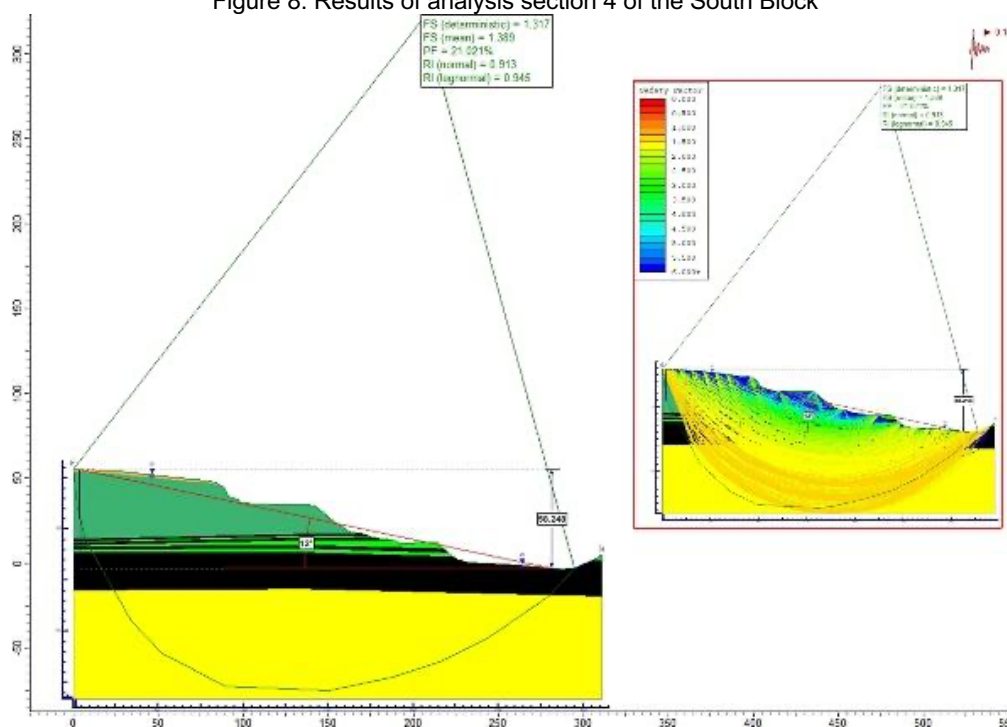
Figure 9. Results of analysis of section 5 of the South Block

The geometry of the South Block Slope section 5 has an altitude of 58,248 meters and a slope of 12°. The safety factor of this section is 1,389 with Probability of failure is 21.02% in the water saturated condition (*full saturated*) which means that the slope geometry in section 5 is declared unstable according to the KEPMEN No.1827 standard.

The results of the analysis of incision 5 on the South block, which previously had slope geometry, had reached a safe safety factor value of 1,732, but the *probability of failure* value still did not meet the standard with a value of 9.09%. The technique functions to reduce the thrust force, enlarge the retainer field. The recommendations made in this incision resulted in a safety factor value of 1,414 and a *probability of failure* value of 0%.

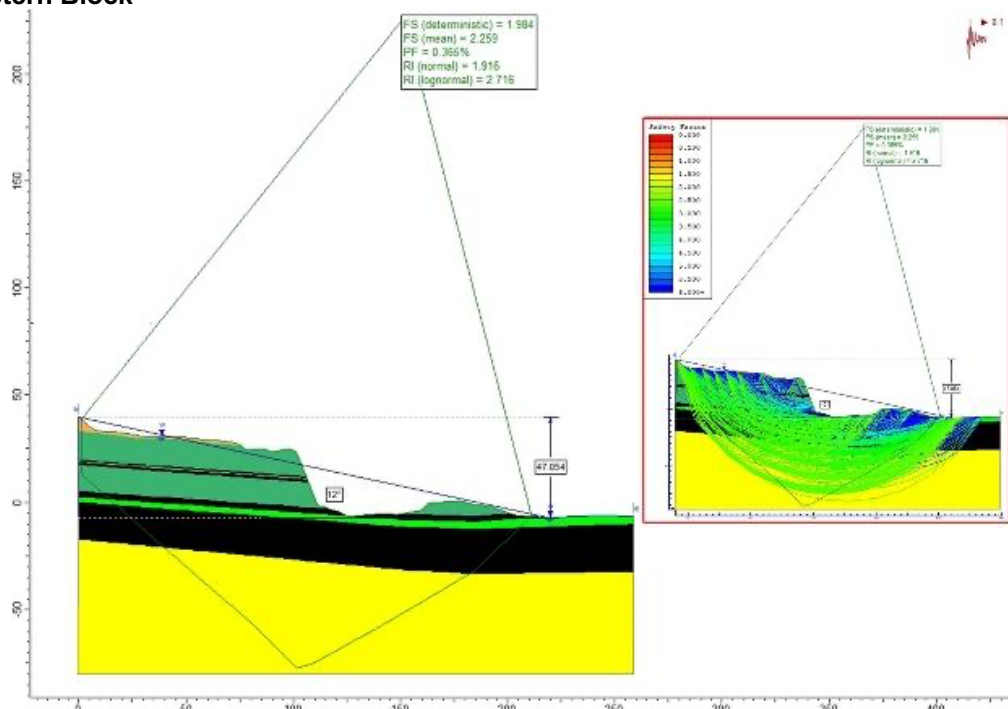
Figure 10. Results of analysis of section 1 of the West Block

The results of the analysis on the slope geometry of the West Block section 1, which has a height of 47 meters with a slope angle of  $12^\circ$ , showed a *Factor of Safety (FS)* value of 2.324 and a *Probability of Failure (PoF)* of 0% in fully saturated conditions. Based on the KEPMEN ESDM No.1827 standard, this value indicates that the slope geometry in section 1 is in a safe and stable condition.

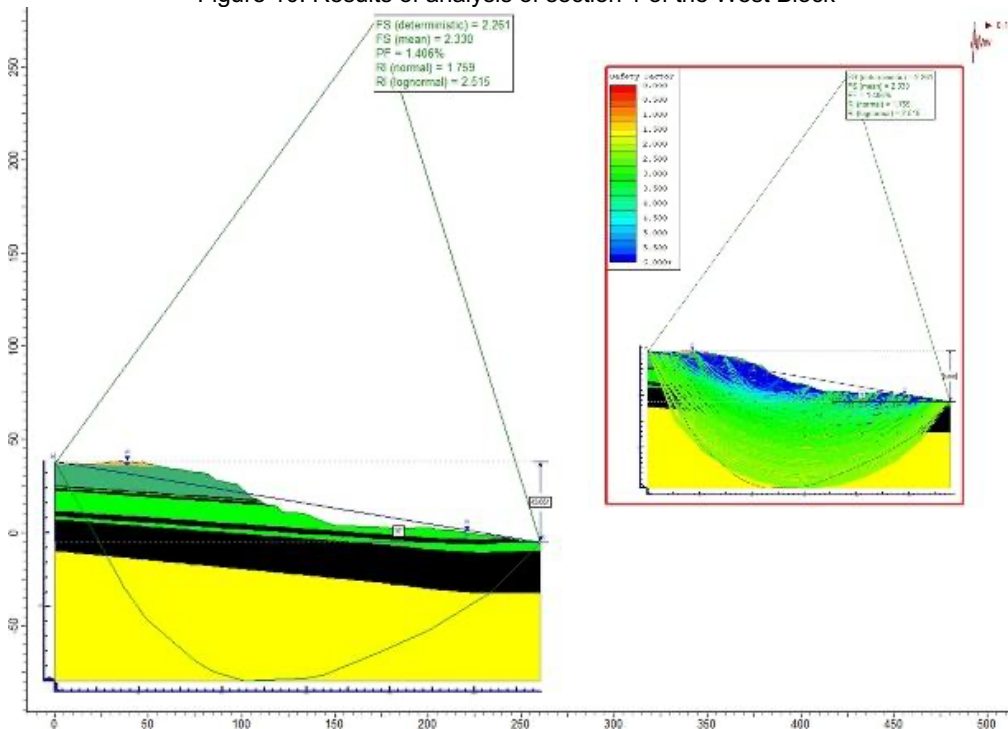
Figure 11. Results of analysis section 2 of the West Block

Furthermore, the Slope Geometry of the West Block Section 2 with an altitude of 43,651 meters and a slope angle of  $10^\circ$  obtained a safety factor value of 2.33 and a probability of failure of 1.41% in water saturated conditions. Based on the same standard reference, the slope geometry in Section 2 is included in the stable category because the value of the safety factor is still far above the minimum limit of slope stability.

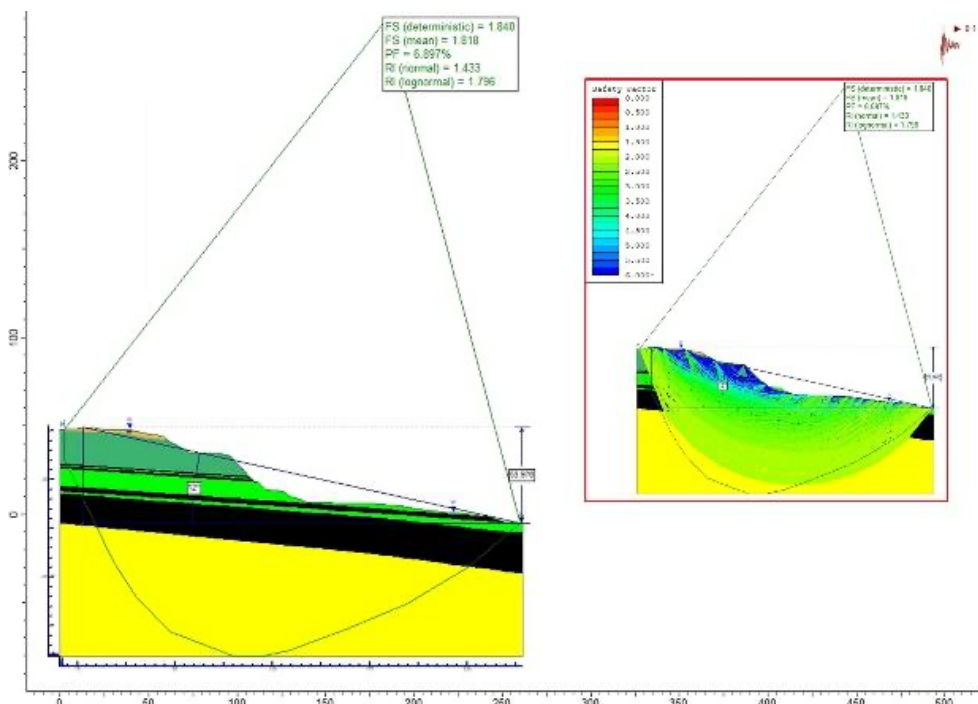
Figure 12. Results of analysis section 3 West Block

In Section 3, the Geometry of the West Block Slope has a height of 53.9 meters with a slope angle of  $12^\circ$  and produces a safety factor value of 1.818 and a probability of failure of 6.90% in water saturated conditions. Although the FS value still exceeds the minimum threshold, the magnitude of the probability of failure shows that the slope geometry in Section 3 is categorized as unstable according to the criteria of the Ministry of Energy and Mineral Resources No. 1827.

The results of the analysis of incision 3 on the West block, which previously had slope geometry, had reached a safe safety factor value of 1,818, but the *probability of failure* value still did not meet the standard with a value of 6.9%. The reconstruction carried out in this section still maintains the overall

slope elevation but changes were made to the *overall slope* from 12° to 17°. The results of the analysis showed that the slope optimization carried out resulted in a safety factor value of 2,343 and a *probability of failure* value of 0%.

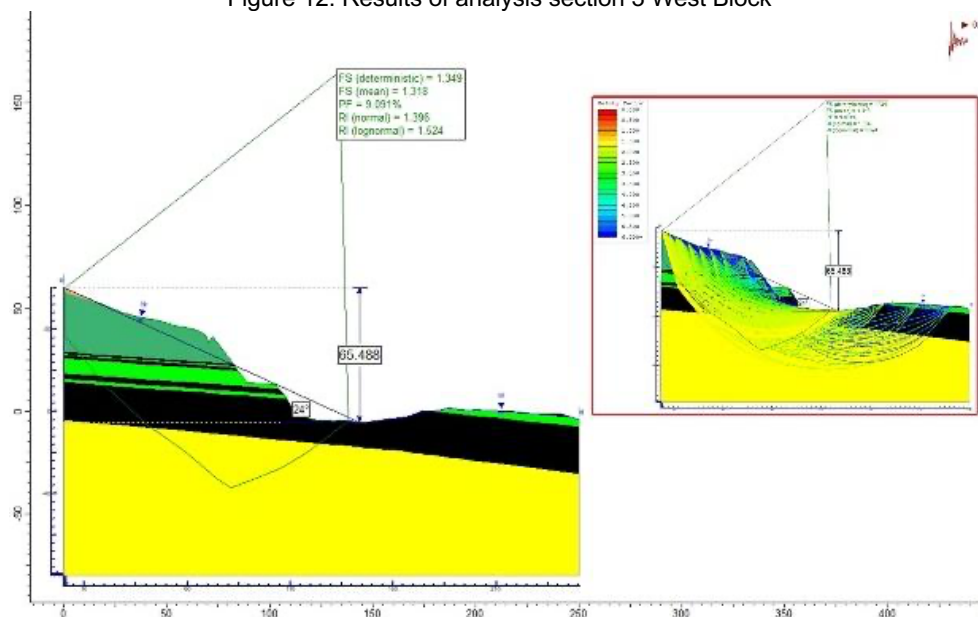
Figure 13. Results of analysis section 4 of the West Block

The analysis in Section 4 of the West Block Slope Geometry shows a slope height of 65.4 meters with a slope angle of  $24^\circ$ . The value of the safety factor obtained was 1.318 with a probability of failure of 9.09% in water saturated conditions. Based on the applicable KEPMEN standards, this section is classified as unstable so it requires special attention and further mitigation measures.

The results of the analysis of incision 4 in the South block, which previously had slope geometry, had reached a safe safety factor value of 1,318, but the *probability of failure* value still did not meet the standard with a value of 10.28%. To improve the stability of the slope, reconstruction was carried out by reducing the elevation of the slope from 65.4m to 51.2m. The recommendations made in this incision resulted in a safety factor value of 2.0 and a *probability of failure* value of 0%

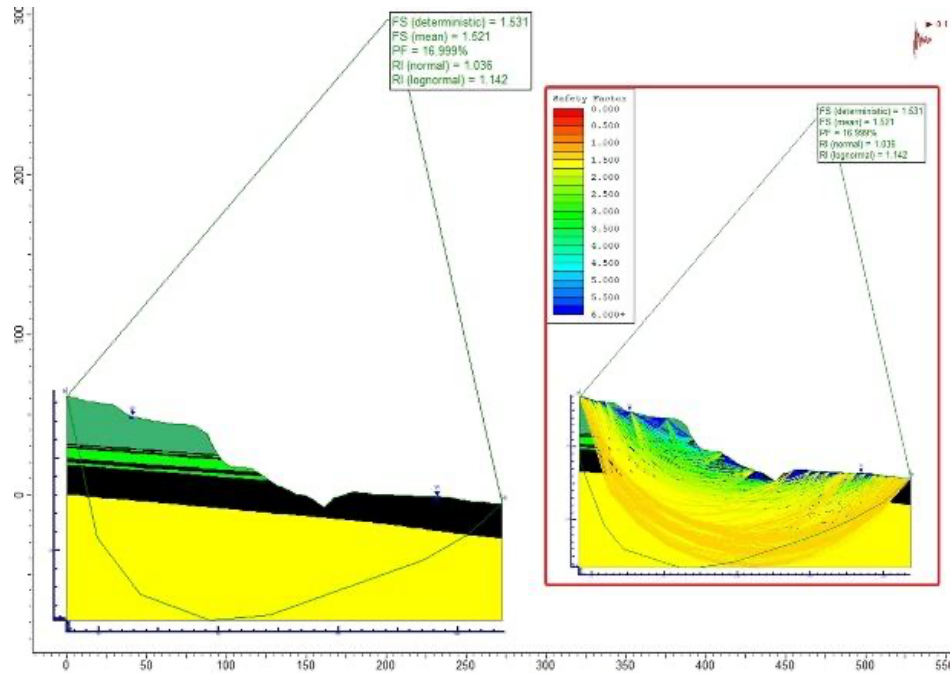
Figure 14. Results of Section 5 Western Block

Finally, the West Block Slope Geometry Section 5 has a height of 69.19 meters and a slope angle of  $23^\circ$ . The value of the safety factor obtained was 1.521 with a probability of failure of 17% in fully saturated conditions. Based on the slope stability assessment criteria from the Ministry of Energy and Mineral Resources No.1827, this section is declared unstable and recommended for design evaluation and handling efforts to minimize the potential for avalanches.

The results of the analysis of incision 5 in the South block, which previously had a slope geometry, had reached a safe safety factor value of 1,521, but the *probability of failure* value still did not meet the standard with a value of 17% because in actual conditions, this section has a relatively steep bench geometry so that reconstruction was carried out but with an *overall slope* which is 23° and the slope elevation of 69m is maintained. The results of the slope geometry analysis after reconstruction resulted in a safety factor value of 2,245 and a *probability of failure* value of 0%.

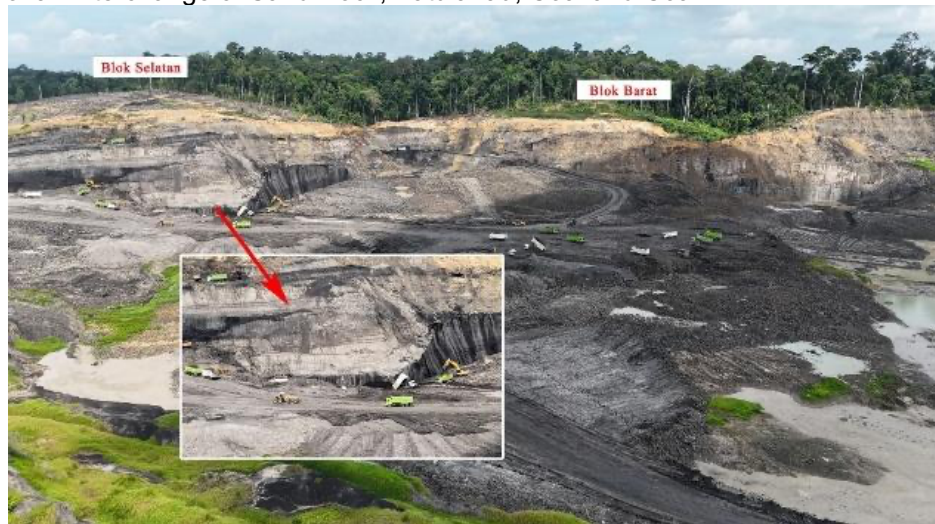
Figure 15. Slope conditions of the research site

From the results of observations in the field, there was material movement/landslide on the slope of the western block that occurred due to saturated soil. High and intensive rainfall causes water to seep into the slopes, increasing the pressure of the pores and reducing the shear strength of the soil. This makes the slope unstable and vulnerable to mass movement. The increase in the weight of the soil mass due to the accumulation of rainwater also adds to the load on the slope which ultimately triggers slope failure and landslides (Bowles, 1989; Moore, 2011).
