# Analysis of Landslide Potential Based on Slopes And Rock Weathering Levels in The Mamampang Area, Tombolopao District, Gowa Regency, South Sulawesi Province

Dwita Safirah<sup>1</sup>, Busthan Azikin<sup>2</sup>

<sup>1,2</sup> Department of Geological Engineering, Faculty of Engineering, Hasanuddin University, Indonesia

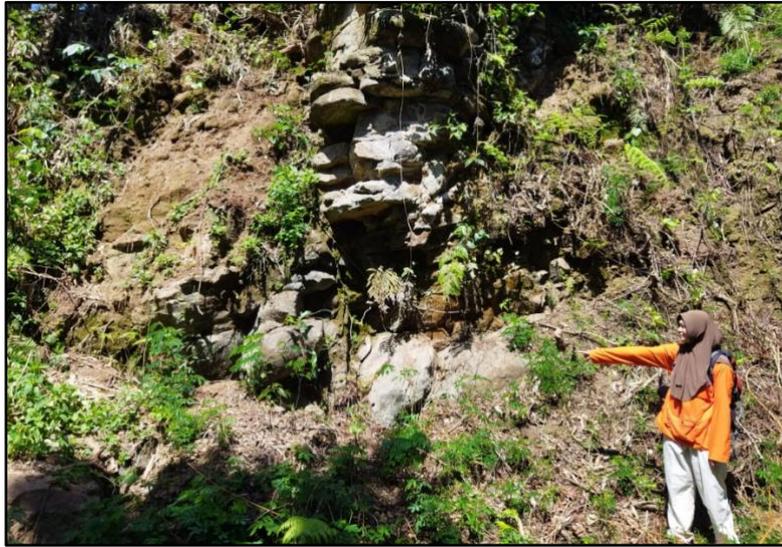
Figure 1 Appearance of station 1 represents the degree of weathering IV with a photographic direction N 215° E

Station 1 (one) as a data collection area representing the degree of weathering IV shows that tufa outcrops that have more than 35% (thirty-five percent) of rock material have been decomposed or disintegrated into soil. There was a weathered appearance from the tufa lithology that showed a change in color from gray to brown. Based on the classification system of the degree of weathering of rocks according to Irfan and Dearman (1978) in Setiadji et al. (2006) this study area was identified as having

a rate of weathering with a Degree of Weathering IV (Strong Weathering). In this area, biological weathering and chemical weathering have occurred (Figure 1).

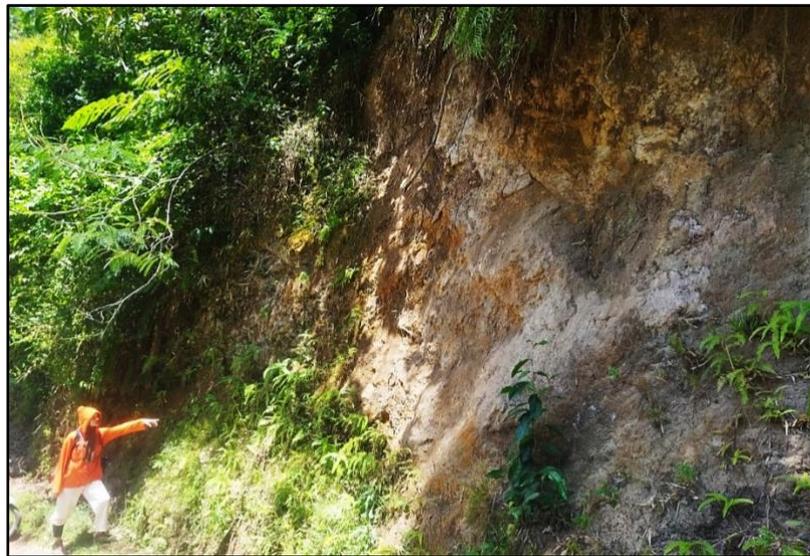
Figure 2 The appearance of station 3 represents the degree of weathering V with the photo direction N 141° E caused by biological weathering and chemical weathering

Station 3 (three) as a data collection area representing the degree of weathering V shows that all rock material has been decomposed or disintegrated into soil, but the rock mass structure is still mostly intact. Based on the classification system of the degree of weathering of rocks according to Irfan and Dearman (1978) in Setiadji et al. (2006) this research area was identified as having a rate of weathering with a Degree of Weathering V (Perfect Weathering). In this area, biological weathering and chemical weathering have occurred (Figure 2).

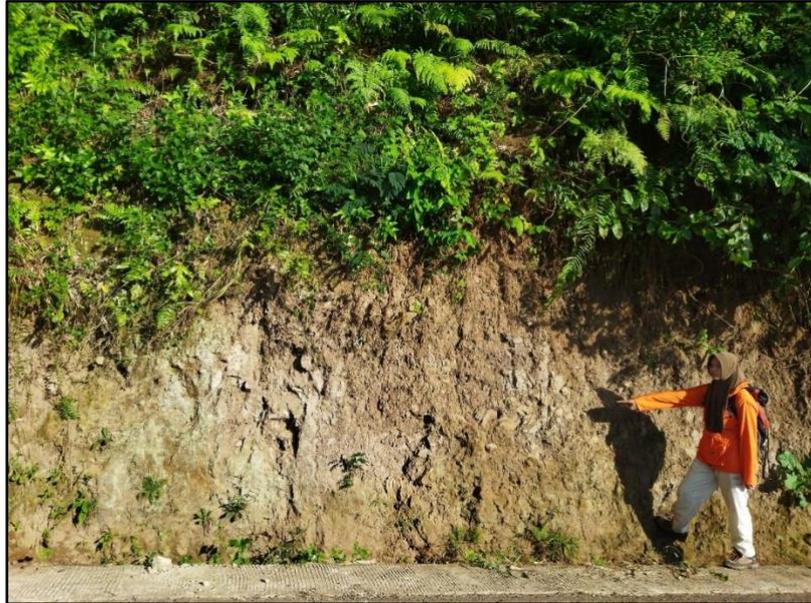
Figure 3 Station 5 appearance represents the degree of weathering V with the photo direction N 149° E caused by biological

Station 5 (five) as a data collection area representing the degree of weathering VI shows that all rock material has turned into soil. The mass and packaging structure of the rock has been damaged, but the soil has not undergone transportation. Based on the classification system of rocks weathering degrees according to Irfan and Dearman (1978) in Setiadji et al. (2006) this research area was identified as having a weathering level with Weathering Degree VI (Residual Soil). In this area, biological weathering and chemical weathering have occurred (Figure 3).

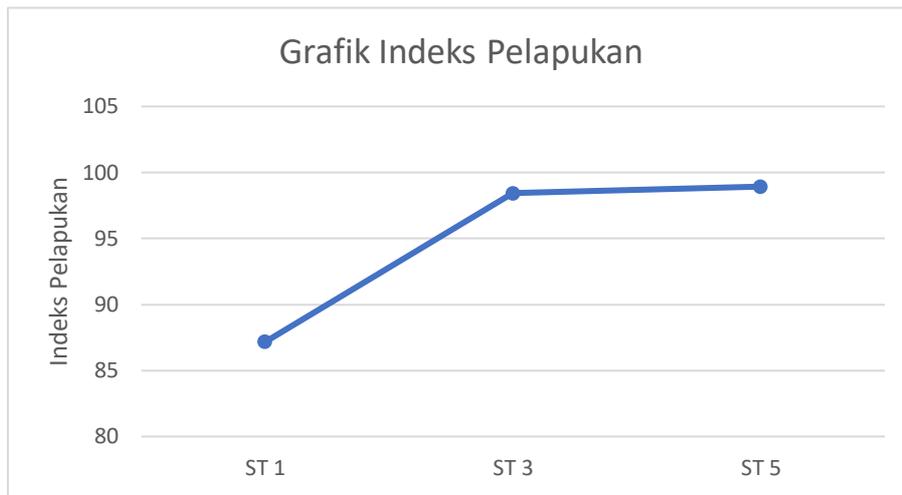
Figure 4 Graph of the chemical weathering index of the research

Based on the results of the calculation using chemical elements obtained from XRF Analysis, it can be seen that the highest to lowest weathering rate is in ST 5 where the weathering rate is known to reach 98.9%. Furthermore, it is located in ST 3 with a weathering rate of 98.5%. The lowest rate of weathering occurred in ST 1 with a weathering rate of 87%.

Based on the results of the analysis of the Chemical Weathering Index and the comparison with the results of direct observations in the field, it is known that the Station 5 area as a station that represents the area with the level of weathering with Weathering Degree VI (Residual Soil) has the highest percentage of weathering.

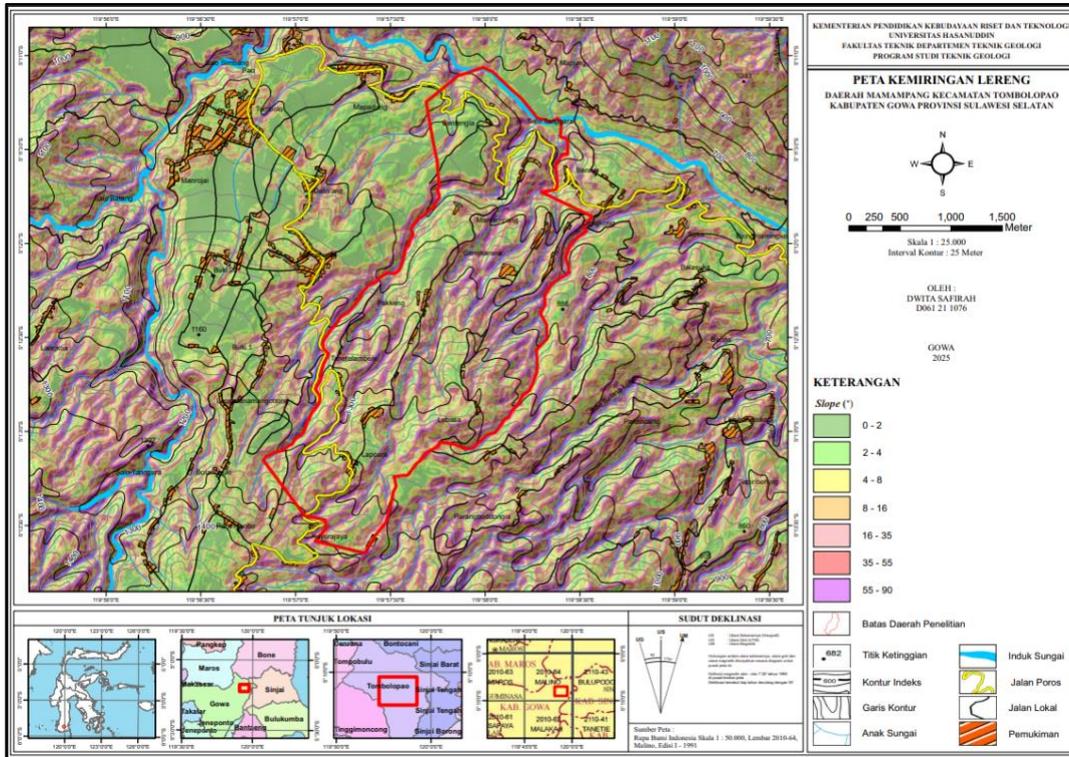
Figure 5 Slope Map of the Research Area

slope shape ranging from Flat to Very Steep (Figure 5). The classification of slope slope used in this analysis uses the classification of Van Zuidam (1985).

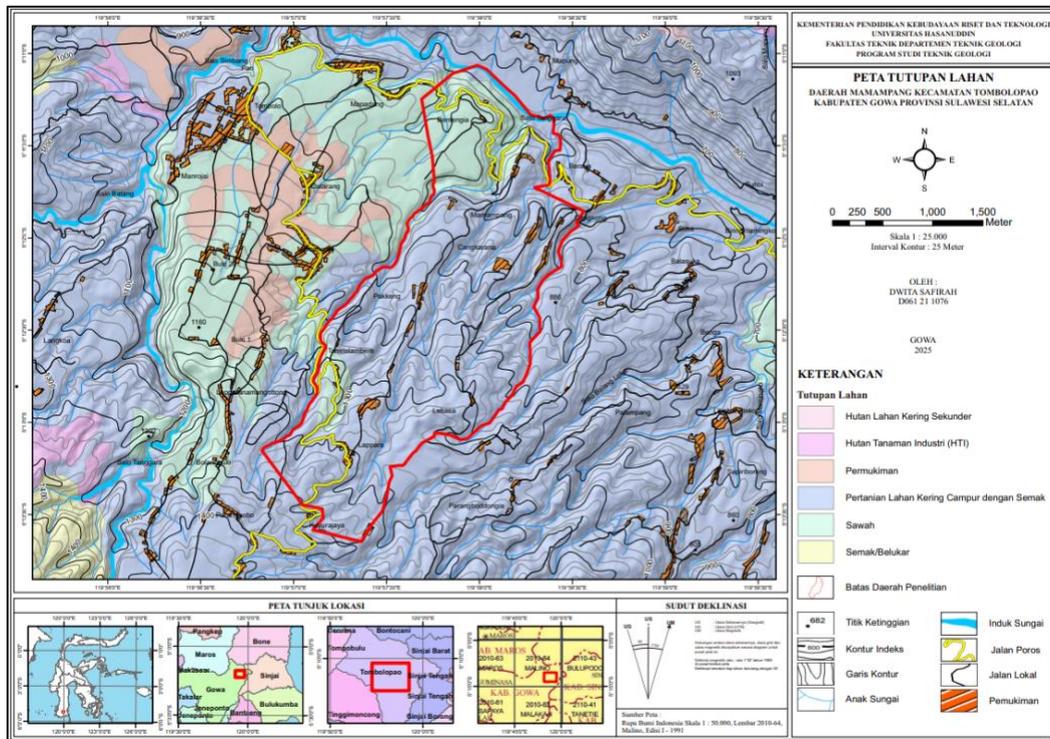
Figure 6 Land Cover Map of the Research Area

Based on the results of land cover digitization obtained from the interpretation of image data, the research area is divided into dry land and rice field agricultural land use. Therefore, land use in an area plays an important role in affecting the level of landslide vulnerability in the research area. The following is a map of the distribution of land cover in the research area (Figure 6).

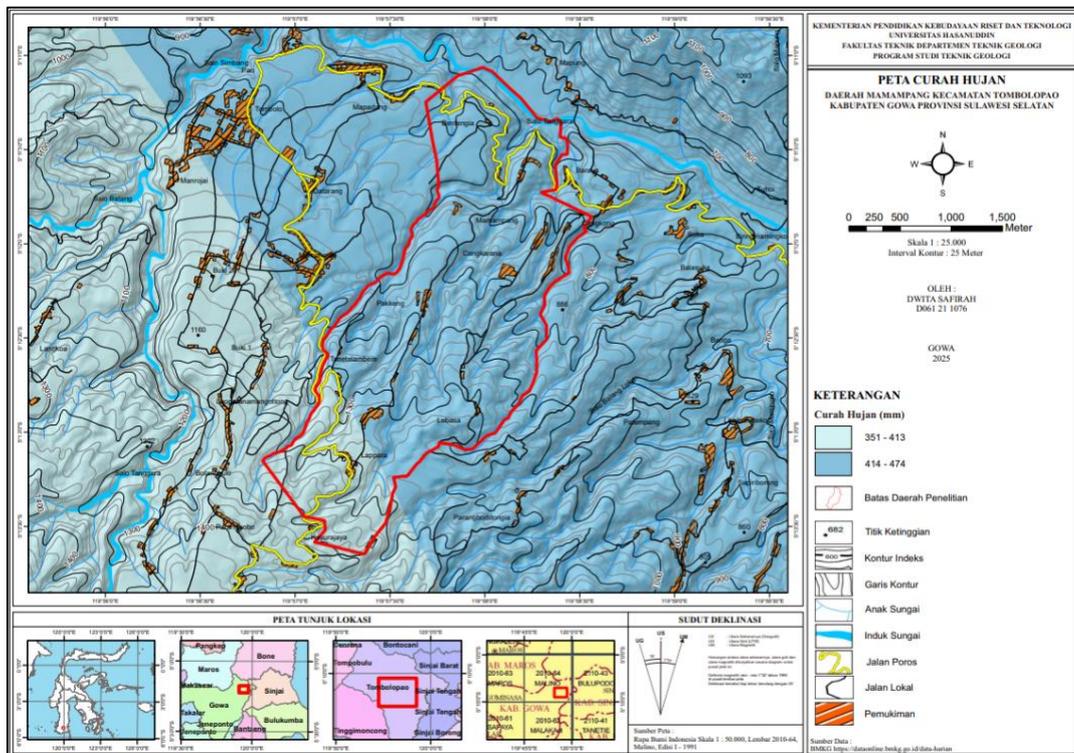
Figure 9 Rainfall Map of the Research Area

The results of rainfall data processing in ArcGIS software in the study area were dominated by low to moderate rainfall intensity (Figure 7).
