## **Slope Stability Analysis of Mining Activities Using Slope Mass Rating of the Poboya Region, Palu City, Central Sulawesi Province**

This study analyzed the level of stability and types of slope avalanches that could potentially occur in mining activities at PIT in the Poboya area of Mantikulore District, Palu City, Central Sulawesi Province, using the SMR method and modeling the mining area. The analysis was conducted by taking large rock samples and discontinuity data using the scanline method in the field. The rock samples were then tested using a point load test to obtain the compressive strength value of the rock, which is included in the 5 parameters of the RMR value and the other 4 are RQD, spacing of the fault plane, condition of the fault plane and groundwater condition of the slope plane. The final SMR result is obtained by combining the RMR value and the correction factor. Based on the RMR calculation results at the location point of the research area, the rock mass class on Slope-1 and Slope-3 is included in class III (medium rock), while the rock mass class on Slope-2 and Slope-4 is included in class II (good rock) with the analysis of the safety factor on the four

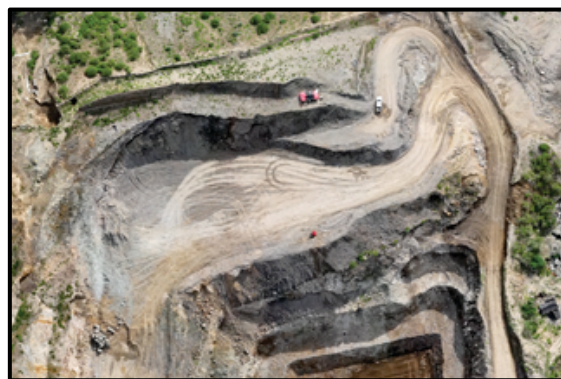
**Figure 2** PIT location of the study area

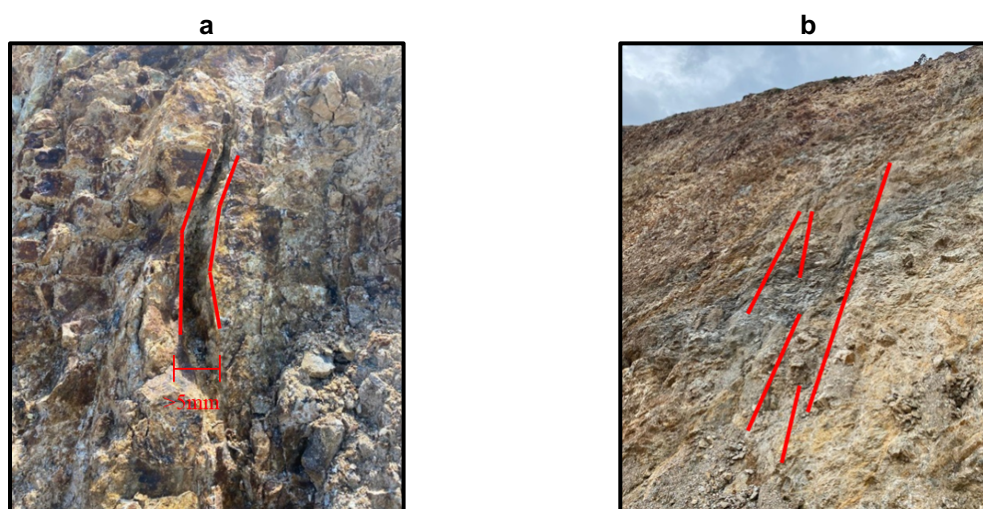
Figure 6 (a) Brittle openings >5mm (b) Brittle continuity

The results of the observation of brittle conditions at the research site based on the observed parameters, namely brittle persistence, brittle aperture width, brittle roughness, infilling material and weathering. Based on the observation of the brittle condition on Slope-1, the average weight of the brittle persistence is 4.63, the average brittle aperture is 3, the roughness of the brittle is 4.03, the infilling material is 4.1 and the weathering level is 3.26. From the observation of the condition of the brittle on Slope-1, a weighted value of 20 is obtained. On Slope-2, the average weight of the brittle continuity is 3.96, the average brittle opening is 3.35, the roughness of the brittle is 3.23, the filler material is 4.23 and the level of weathering is 2.72, so a weighted value of 18 is obtained. Slope-3, obtained the average weight of brittle continuity is 4.58 average brittle opening is 3.09 brittle roughness is 3.10 fill material is 3.56 and the weathering rate is 1.94, then obtained a weighted value of 16. Slope-4, obtained the average weight of brittle continuity is 4.58 average brittle opening is 4.03 brittle roughness is 2.93 fill material is 4.70 and the weathering rate is 3.41, then obtained a weighted value of 18.

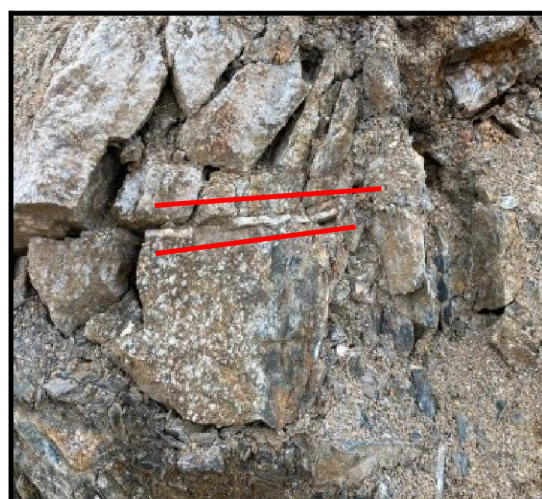
Figure 8 Calcite vein as filler material
