## **Analysis of the Stability of the Mining Site Slope on Bunyu Island, Bulungan Regency, North Kalimantan Province**

<sup>1-2</sup> Geological Engineering Department, Faculty of Engineering, Universitas Hasanuddin, Indonesia

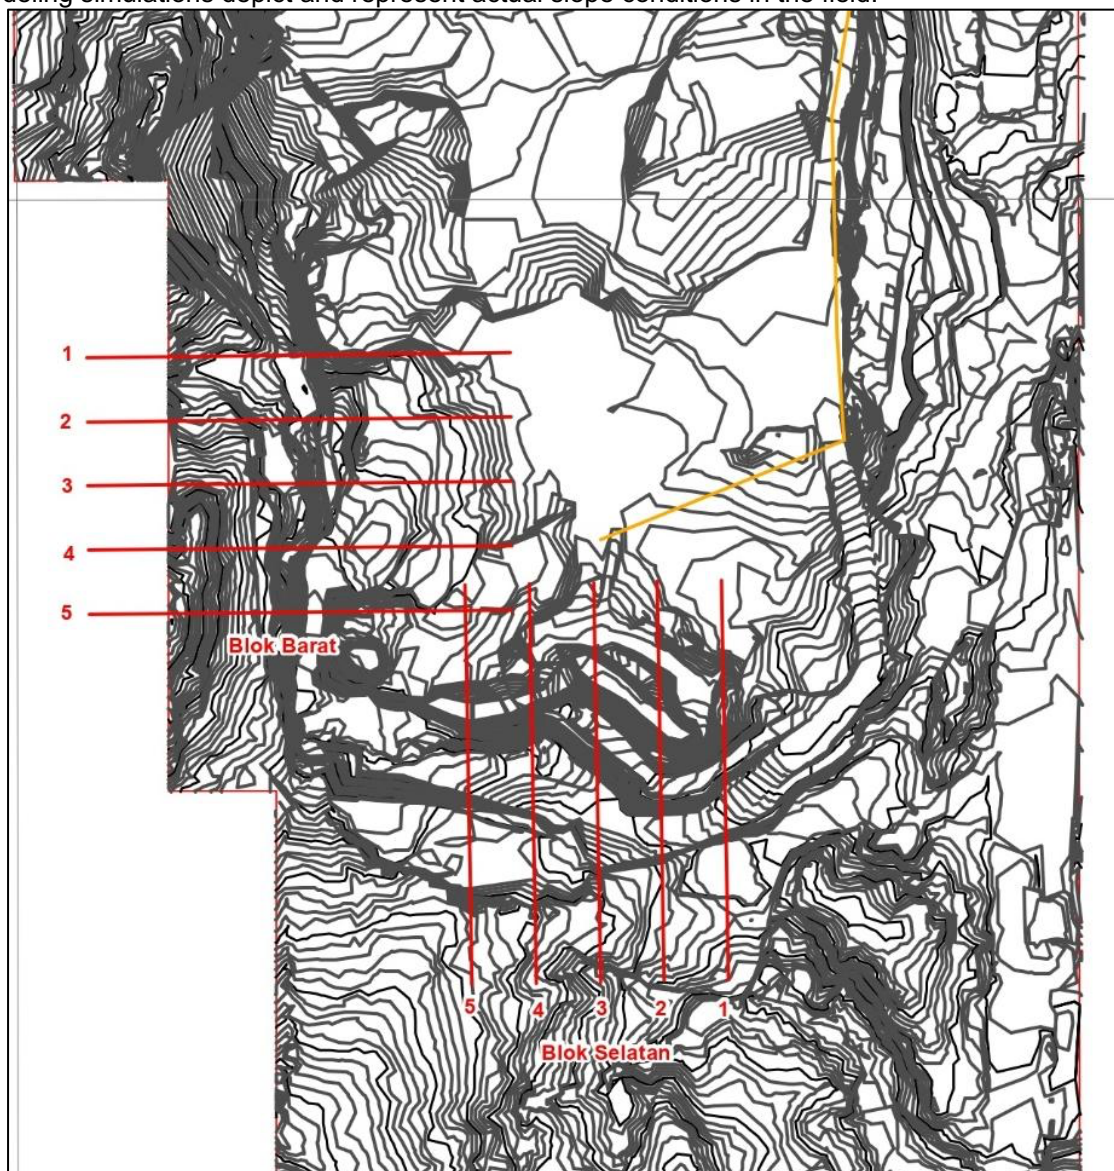
Figure 3. Cross-section of the South and West Block Slopes

In this study, the cross-section used is the actual slope geometry in the South and West blocks in October 2024.

Based on the results of the analysis of the geometry of the slope of section 1 which has a slope height of 44,762 meters and a slope slope of 18°, a *Factor of Safety (FoS)* value of 2,543 was obtained with a *Probability of Failure (PoF)* obtained of 0% in a fully saturated condition which means that the slope geometry in section 1 is declared stable according to the KEPMEN 1827 standard.

Then for the results of the analysis of the geometric stability of the slope section 2 which has a slope height of 64,318 meters and a slope slope of 32°, it produces a value of *Factor of Safety (FoS)* 1,574 with *Probability of Failure* is 4.39% (Figure 14) in the water saturated condition (*full saturated*) which means that the slope geometry in section 2 is declared stable according to the KEPMEN No.1827 standard.

In section 3 with a slope height of 71,678 meters and a slope of 23°, the value of *Factor of Safety (FoS)* of 1,596 with *Probability of Failure (PoF)* is 9.20% in the water saturated condition (*full saturated*). Although the FoS value is still above the minimum limit, the magnitude of the PoF value shows that the slope geometry in this section tends to be unstable according to the KEPMEN No.1827 standard.

The analysis in section 4 has an altitude of 64,876 meters and a slope of 20°. The safety factor of this section is 1,831 with Probability of failure is 5.15% in the water saturated condition (*full saturated*) which means that the slope geometry in section 4 is declared unstable according to the KEPMEN No.1827 standard.

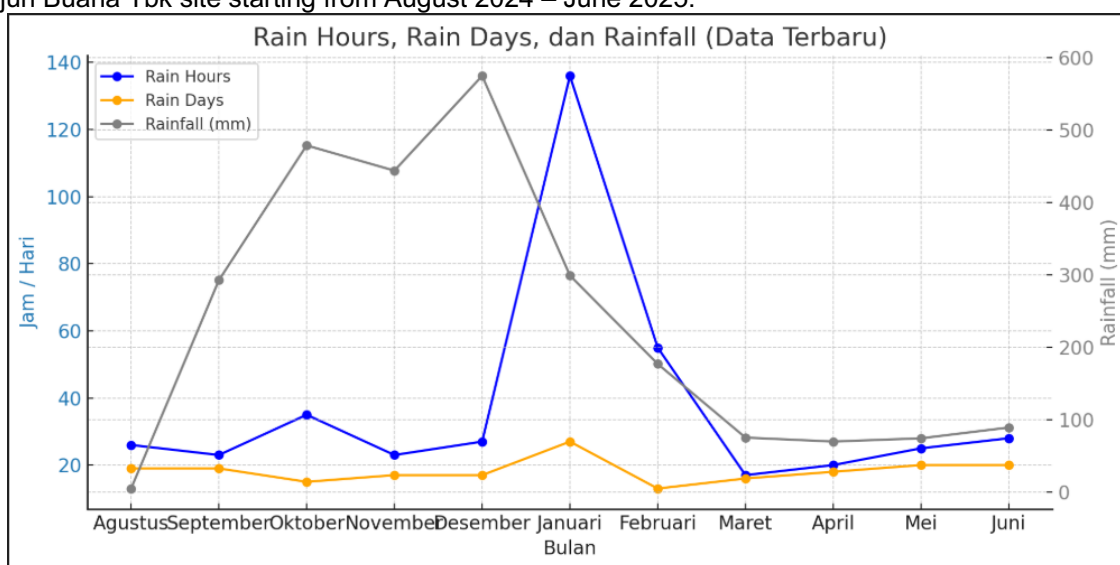
Figure 4. Rainfall Graph (Source: PT Garda Tujuh Buana)

Based on the rainfall graph, the highest peak of rain duration occurred in January with a total of about 135 hours of rain, much higher than in other months, while the number of rainy days also increased to more than 25 days. However, rainfall actually decreased from December to January. This indicates that in January the rains tend to occur more frequently and for longer, but with a lighter intensity than in December. Therefore, in December and January there is a good chance that the soil will be in a saturated condition.
